Navajo Abandoned Uranium Mine

Site Screen Report

Mine Name: Taylor Reid No. 1
Mine IDs: 261, 708

April 2012

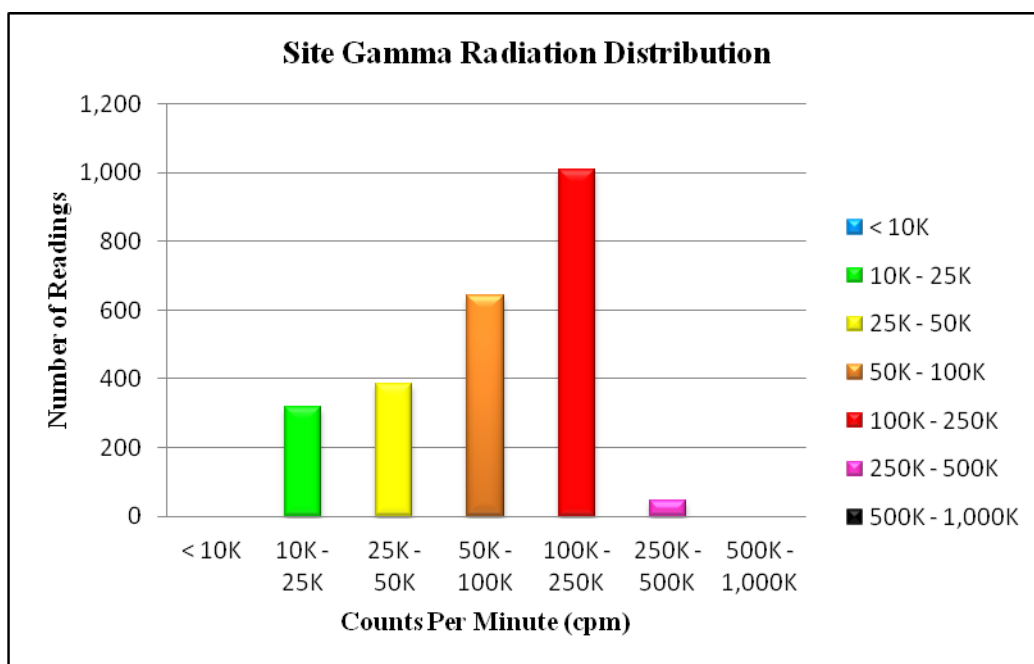
A total of 2,400 gamma radiation measurements were collected from the mine site, ranging from 14,846 cpm to 345,372 cpm. Maximum levels of approximately 345,000 cpm were found in the vicinity of the waste rock. The measurements are represented in Figures 1 and 2.

Site Gamma Radiation Statistics	
Number of Readings	2,400
Minimum (cpm)	14,846
Maximum (cpm)	345,372
Mean (cpm)	98,949
Median (cpm)	88,394
Standard Deviation	65,479

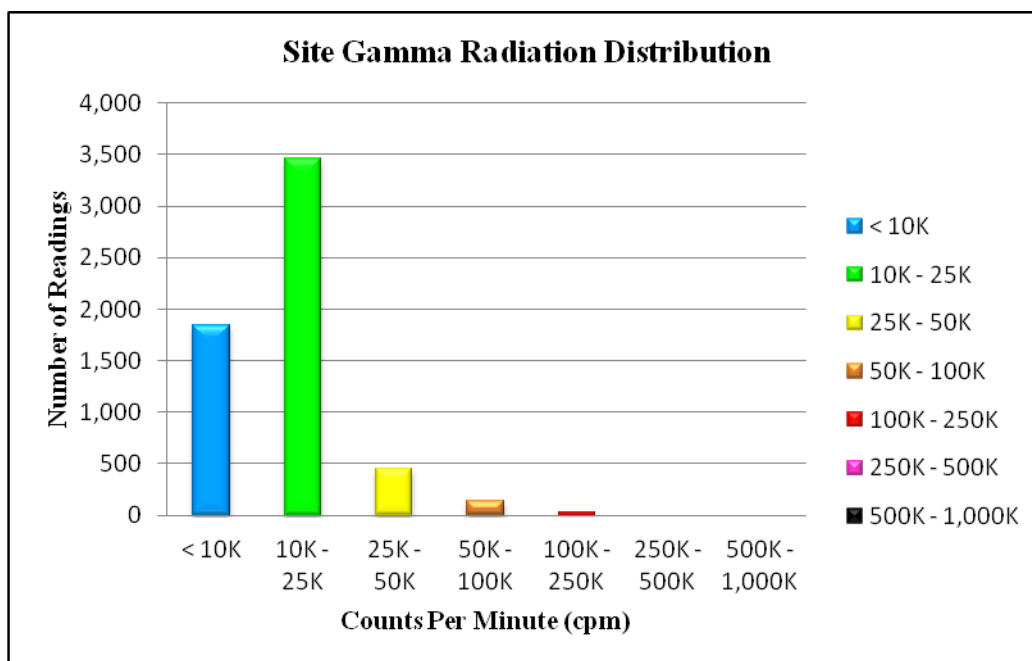
A total of 5,919 gamma radiation measurements were collected from the mine site, ranging from 5,097 cpm to 191,703 cpm. Maximum levels of approximately 190,000 cpm were found near the adit. The measurements are represented in Figures 1 and 2.

Site Gamma Radiation Statistics	
Number of Readings	5,919
Minimum (cpm)	5,097
Maximum (cpm)	191,703
Mean (cpm)	16,036
Median (cpm)	12,660
Standard Deviation	14,776

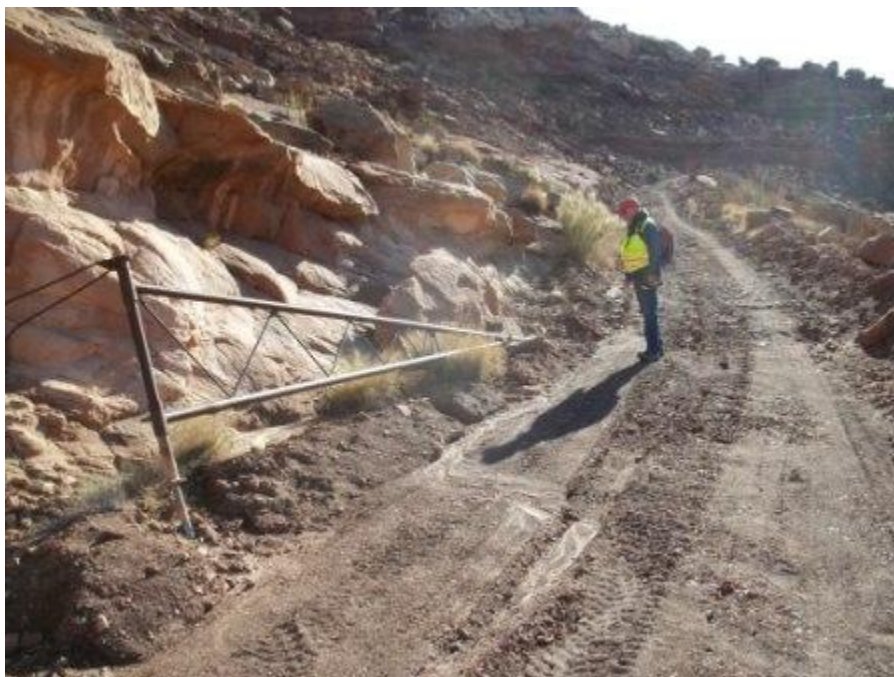
Photo 2

Mine Site #261 – Road / gate area

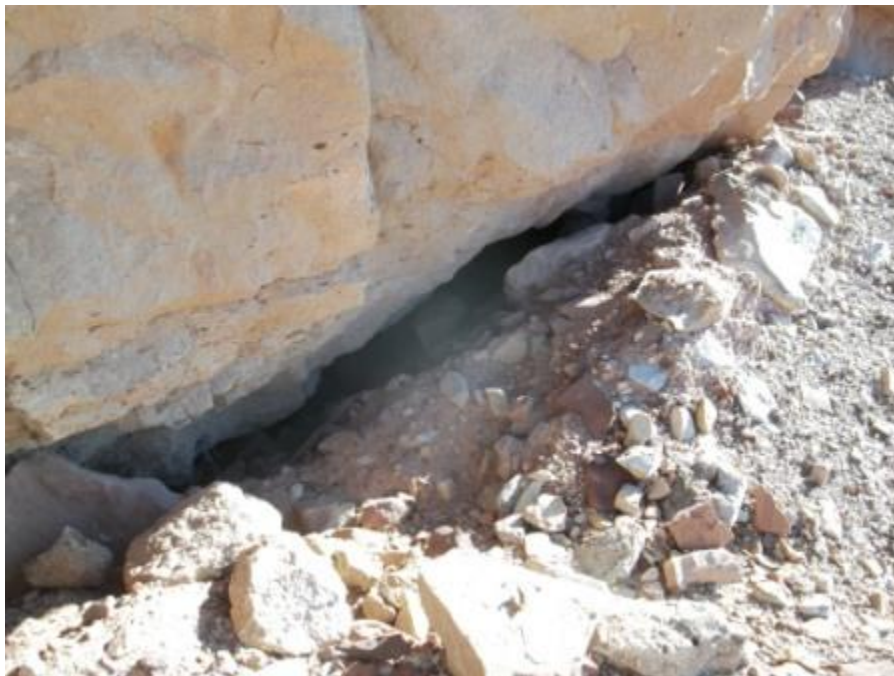
Photo 4

1 adit, covered with waste rock

Waste rock is pushed up against adit, and continues at least 200' downslope

Mine Site #261 - Adit

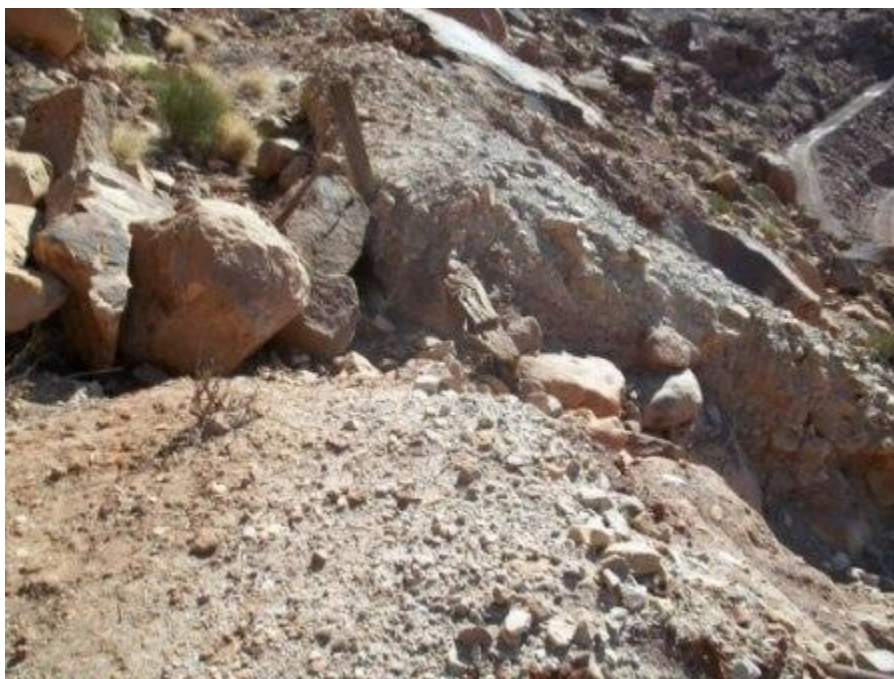
Photo 11

1 adit, appears caved in - waste rock pushed up against adit entrance

Waste rock piled against old road to site, and sheet of waste below

Mine Site #708 - Adit

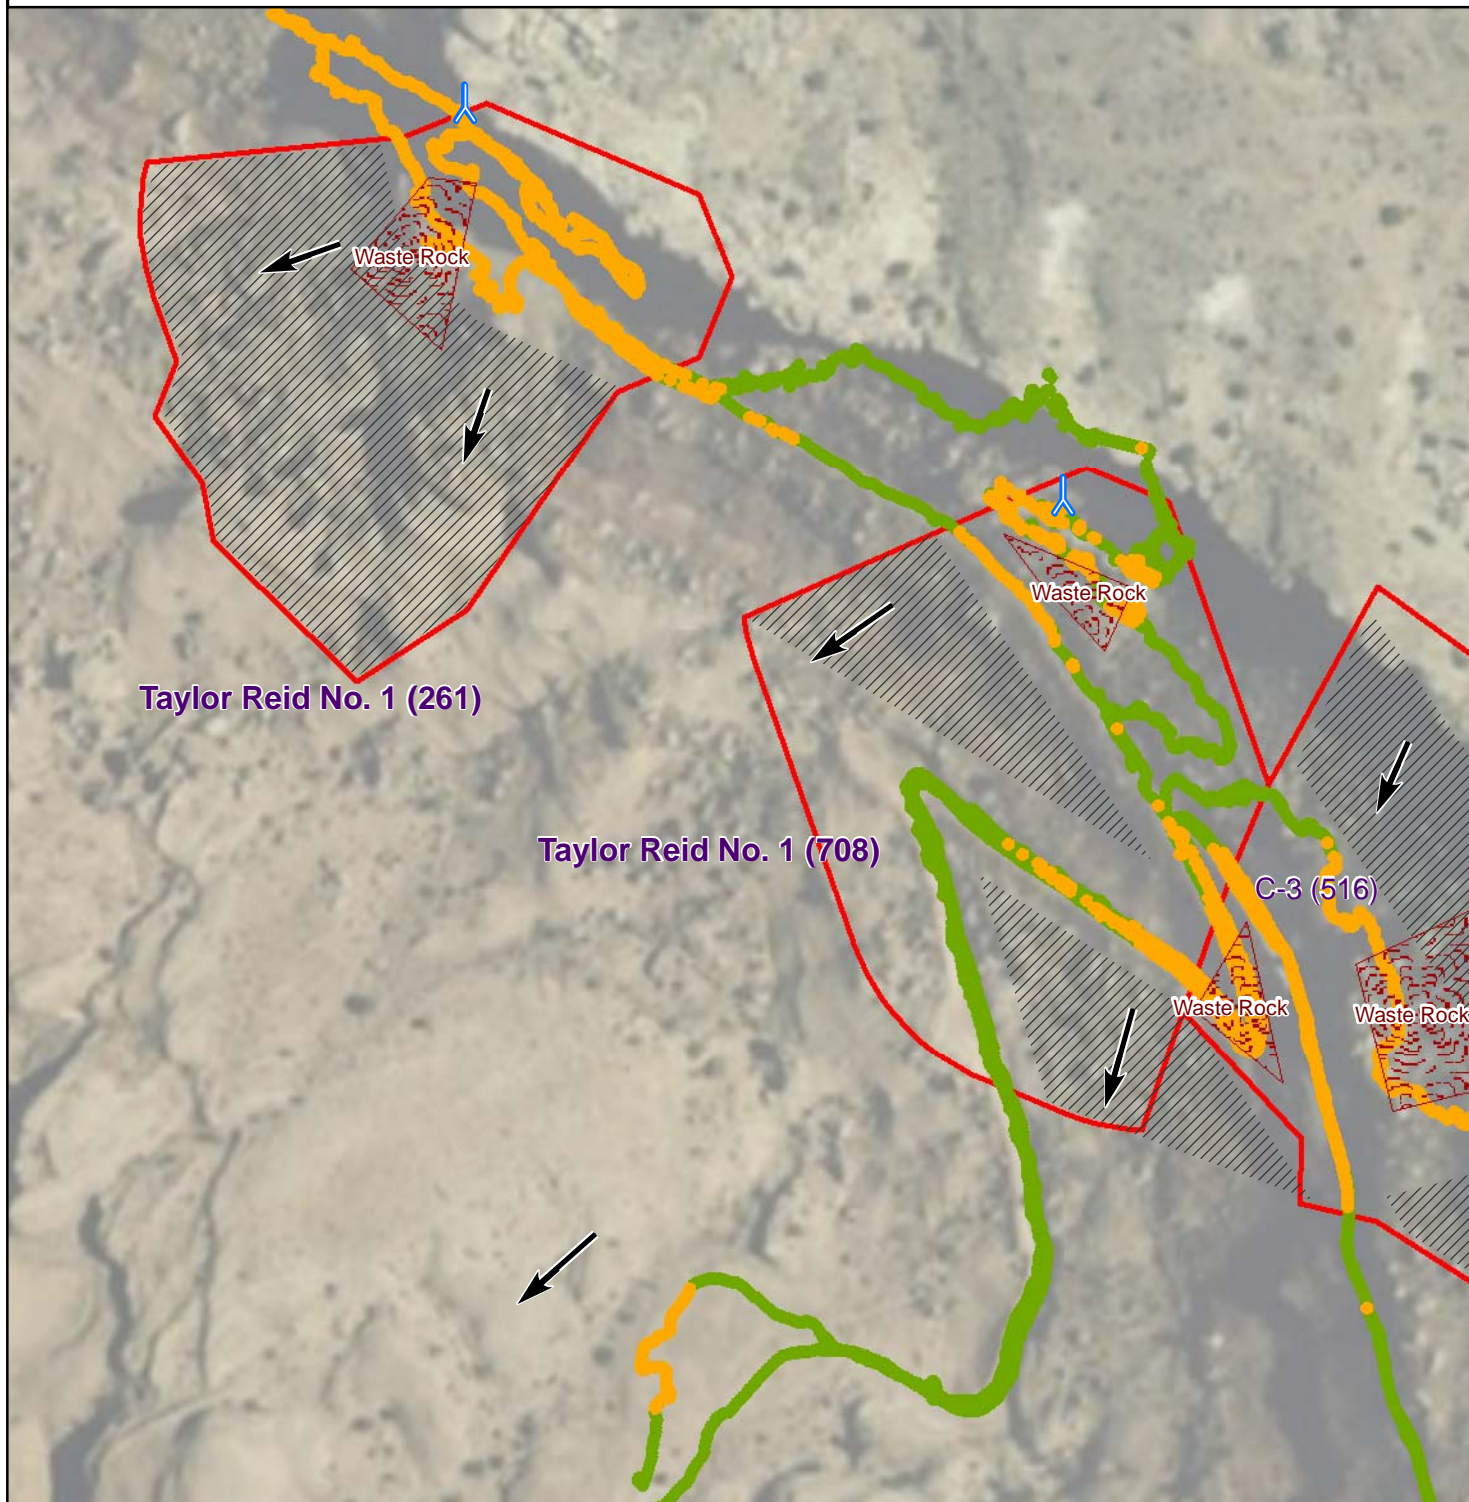
**Figure 1 - Gamma Radiation Measurements, Above Two Times Background
Taylor Reid No. 1 (261, 708)
Oljato Chapter, Navajo Nation**

Gamma Radiation Measurements

- < 2X Background
- > 2X Background

Measured as counts per minute (cpm)

Average background 9,239 cpm

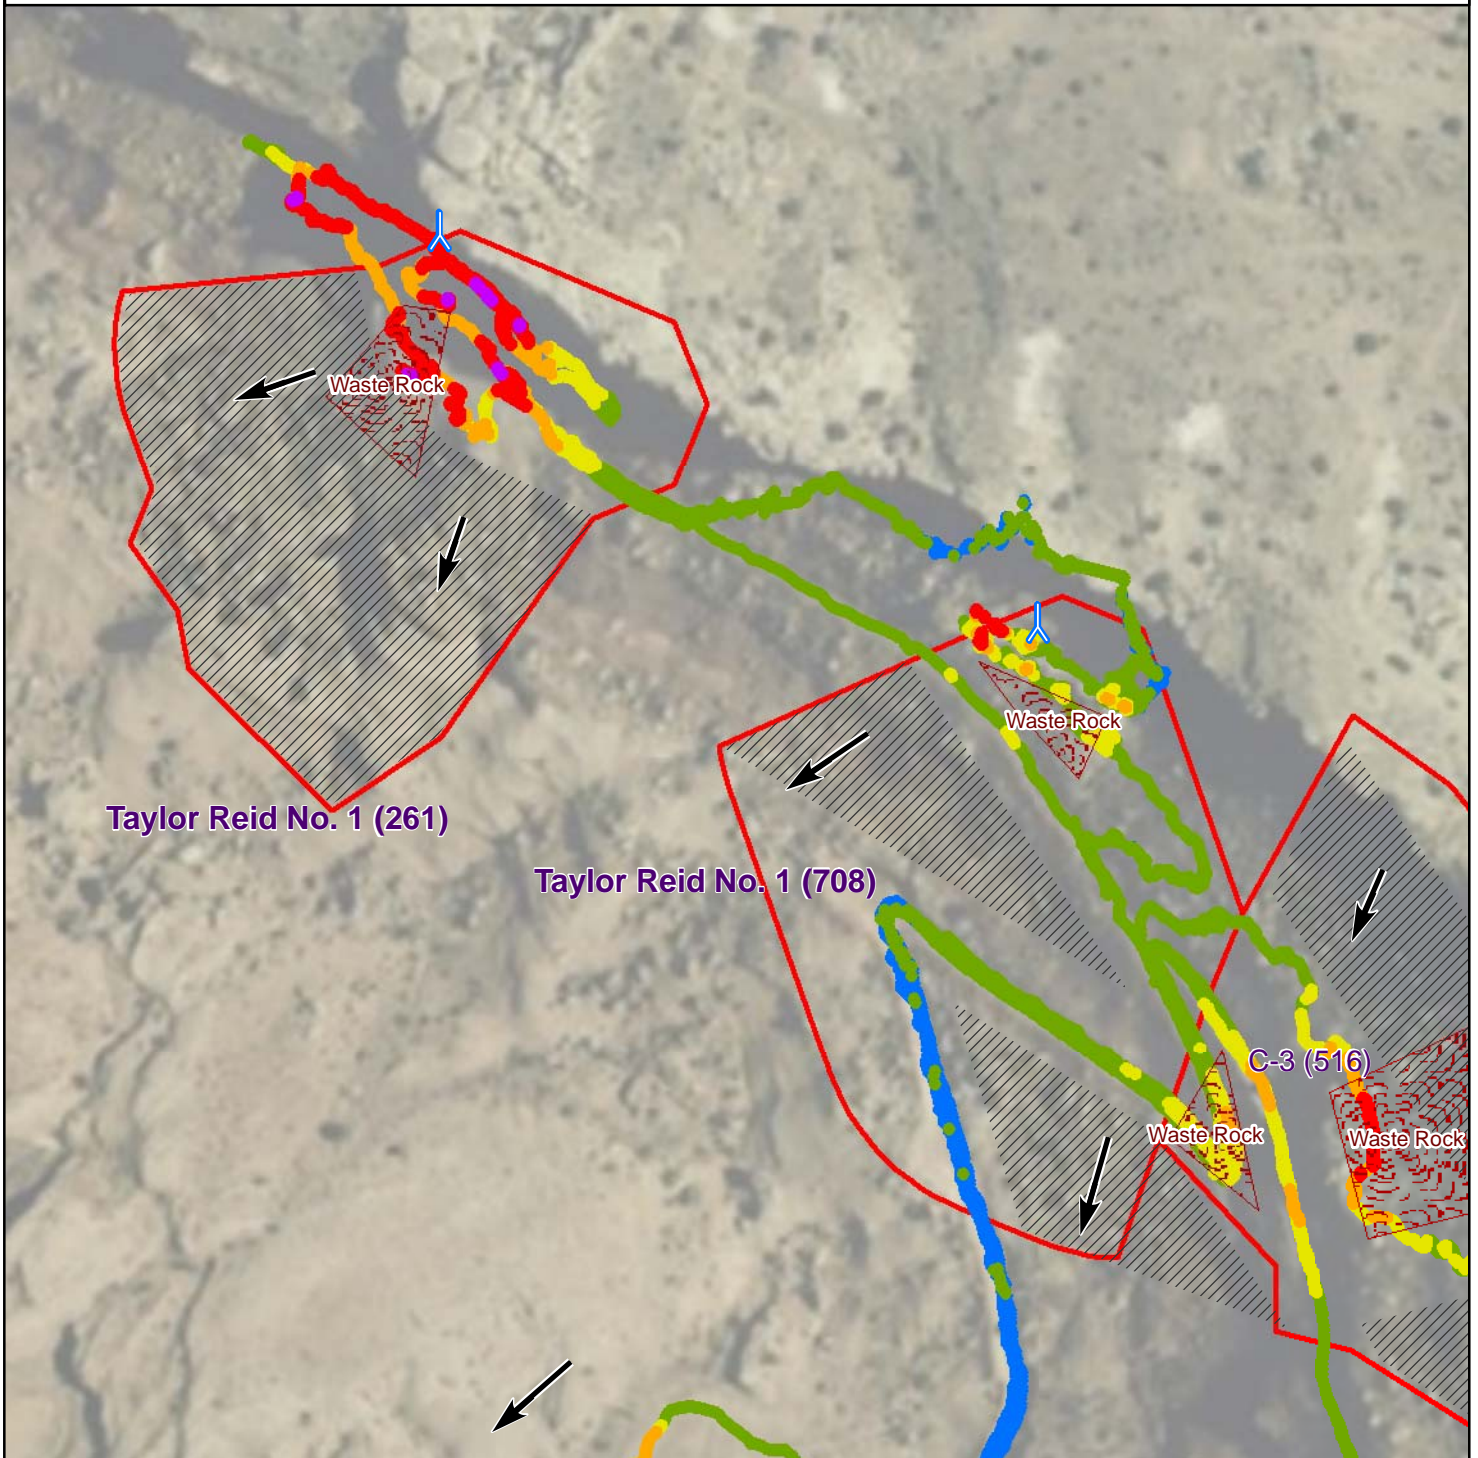
Figure 2 - Gamma Radiation Measurements
Taylor Reid No. 1 (261, 708)
Oljato Chapter, Navajo Nation

Gamma Radiation Measurements

- 0 - 10,000 cpm
- 10,000 - 25,000 cpm
- 25,000 - 50,000 cpm
- 50,000 - 100,000 cpm
- 100,000 - 250,000 cpm
- 250,000 - 500,000 cpm
- 500,000 - 1,000,000 cpm

Average background 9,239 cpm

Measured as counts per minute (cpm)
